Craanen Technical Services

PHYSICAL DESCRIPTION
&
MECHANICAL SYTEMS, ETC.

**Project Name: XXXX Hotel
Inspection date: May 1st, 20xx**

**Company name: XXXX LLC
Report Date: May 3rd, 20xx**

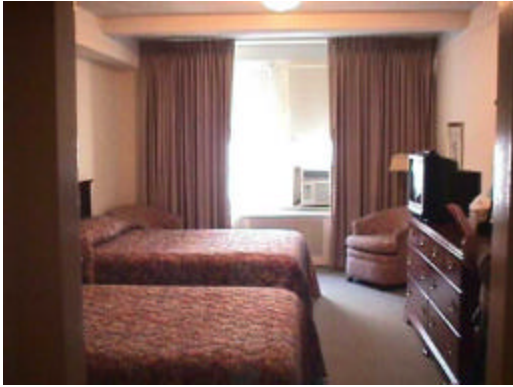
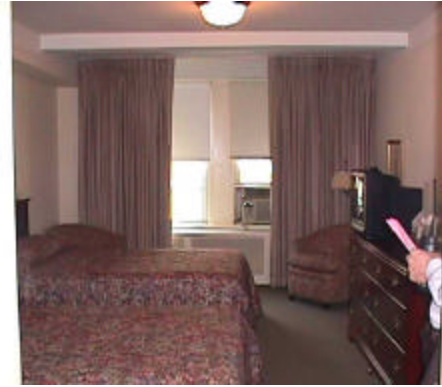
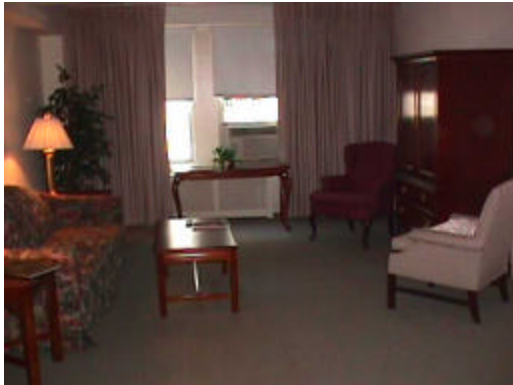
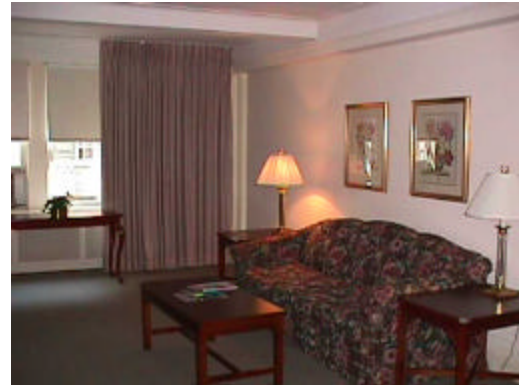
The rooms are maintained and piecemeal upgraded, it must be stated that the rooms are below our regular level of standard. Renovation is needed.

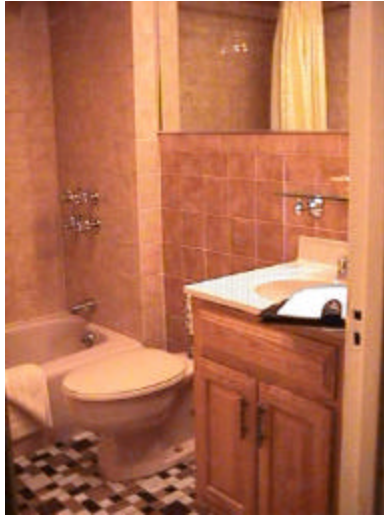
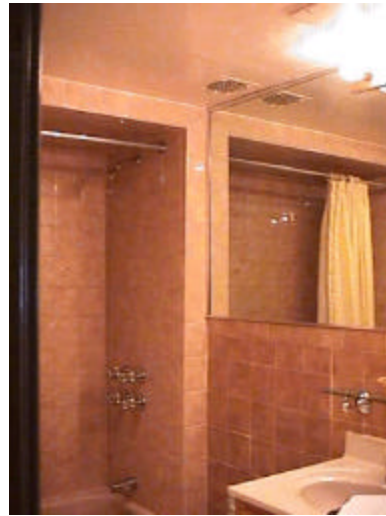
2. Bathrooms:

The Bathrooms are maintained, some bathrooms have been renovated but generally the bathrooms are dated and are in need for renovation.

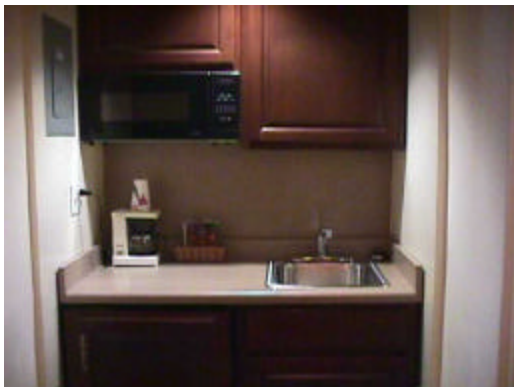
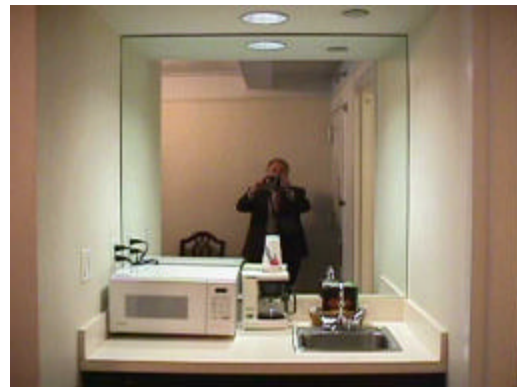
3. Kitchens:

Most rooms do have kitchenettes, and the 6 I have seen were in good condition. The top two floors have overhead cabinets in the kitchenettes.

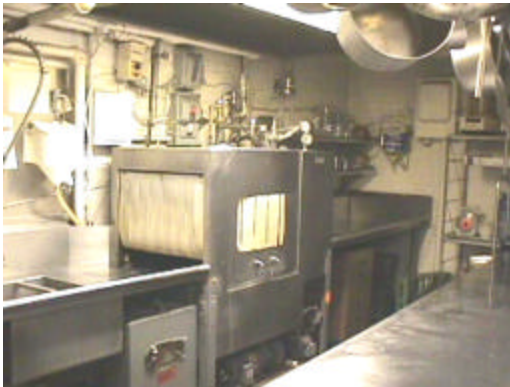
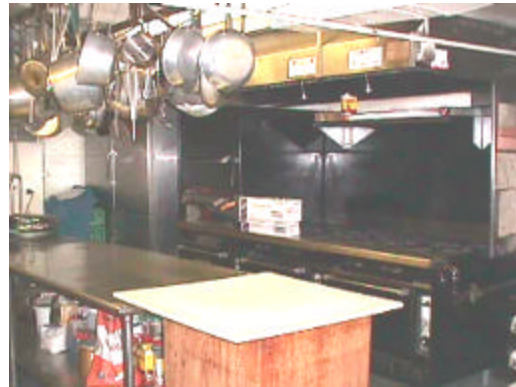
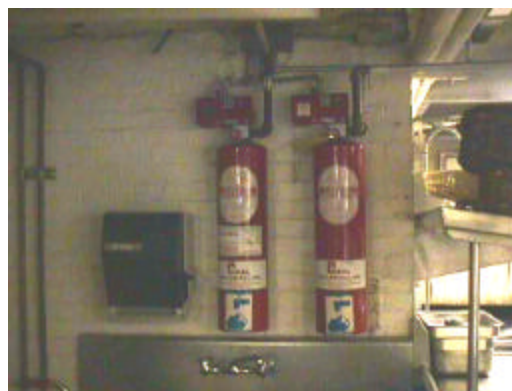
KITCHEN:

The kitchen is located in the basement, it is rarely used for actual cooking. According to the chief engineer the range is in working condition, 2 large refrigerators are out of order, the walk-in refrigerators are in working condition. It seems that a major renovation of the area and equipment is needed if the kitchen need to be used.

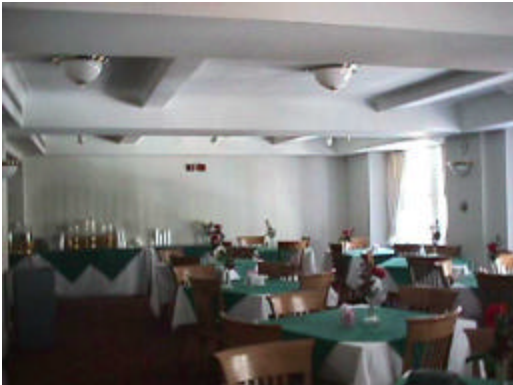
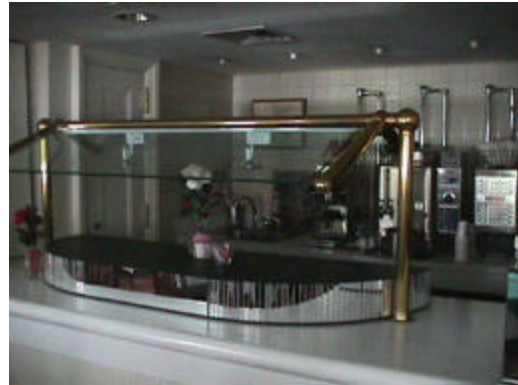
Presently the Hotel does not have meeting rooms, the breakfast room could be used after 11.00 AM or if no breakfast would be served. The breakfast room needs renovation / upgrading.

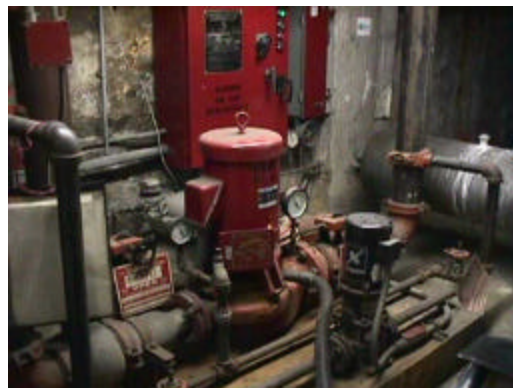
There are 3 Siamese Fire department connections on 57th street
Pumps for the fire system are located at the roof and in the basement.

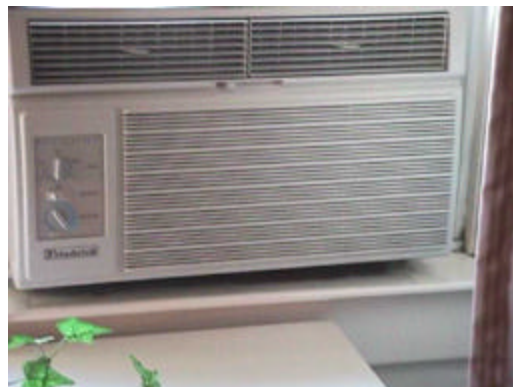
90 % of the Window Units are “Friedrich” the remainder a mixture from which the most are “Fedders”
The age of the units varies.
