Craanen Technical Services

PHYSICAL DESCRIPTION
&
MECHANICAL SYTEMS, ETC.

**Project Name: XXXX Hotel
Inspection date: May 1st, 20xx**

**Company name: XXXX LLC
Report Date: May 3rd, 20xx**

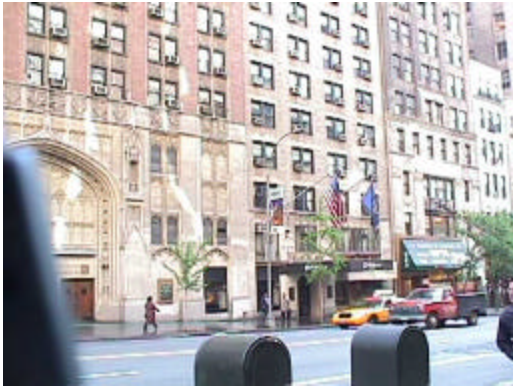
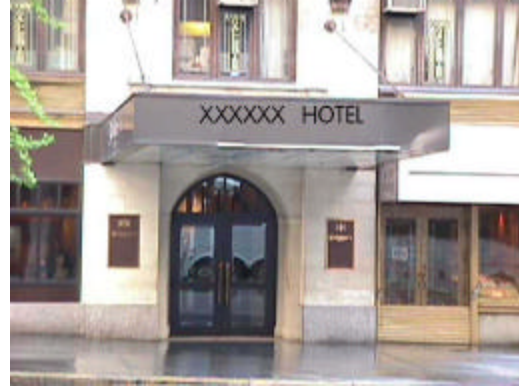
The hotel occupies a total of 186,000 sq.ft. and is 17 stories tall, an additional 40,830 sq.ft. is occupied by the Owning Company. The Hotel originally opened in 1931.
